Partial Discharge Detection using Transient Earth Voltage & Ultrasound Testing

BENEFITS AND EXPERIENCES OF NON-INTRUSIVE PARTIAL DISCHARGE MEASUREMENTS ON MV SWITCHGEAR

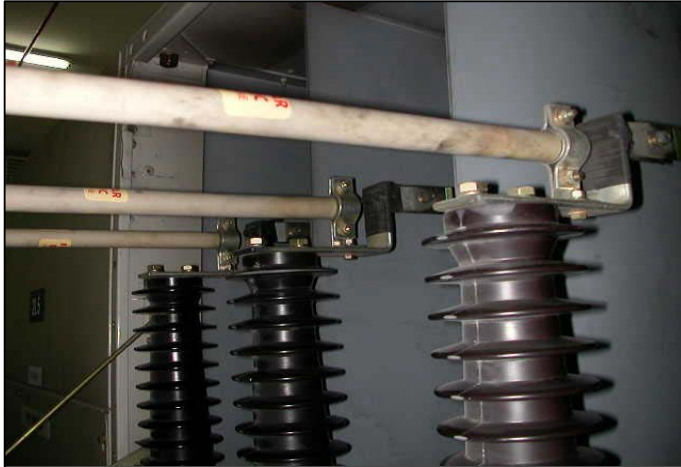
Equipment: Bushings at VT Terminal

Partial Discharge Locator Reading: 24dB

Defects: Discolouration on Bushings & Busbar

Possible Cause: Ionization due to surface discharge

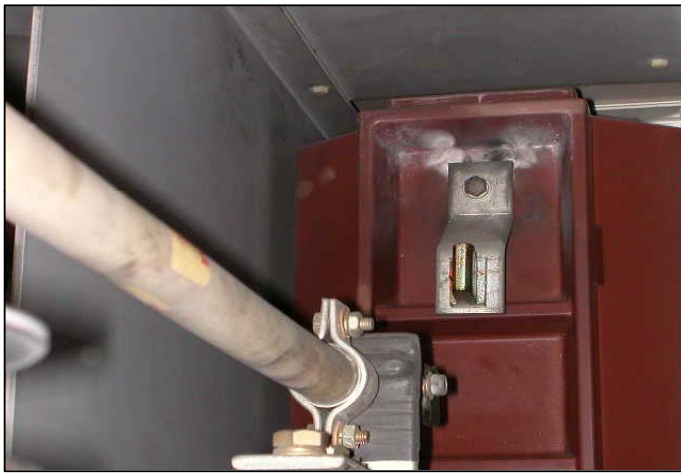
Equipment: Busbar Termination at VT Terminal

Partial Discharge Locator Reading: 32dB

Defects: Discolouration on Busbar & Insulator Surface

Possible Cause: Surface Ionization due to sharp corners on busbar

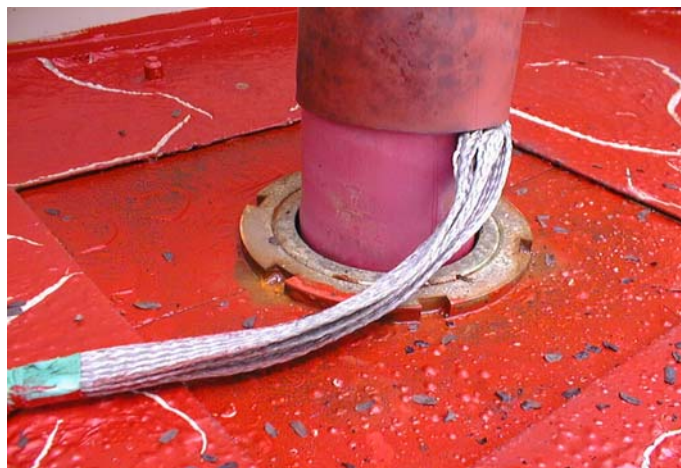
Equipment: 11kV HV Cable Base plate

Partial Discharge Locator Reading: 35dB

Defects: Bubbling of paintwork on baseplate

Possible Cause: Corrosion caused by Nitric acid produced from Ozone

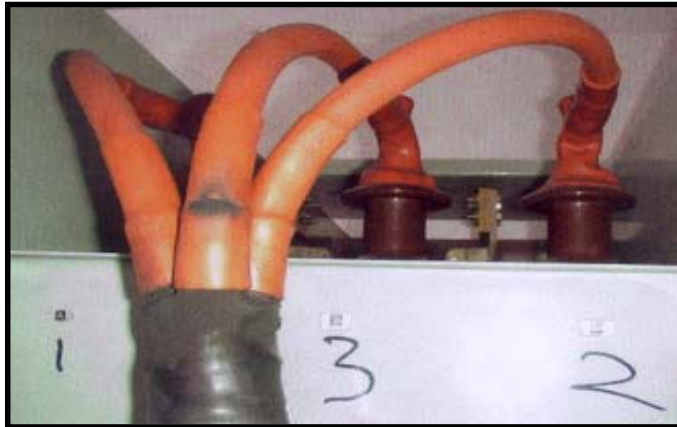
Equipment: Cable Termination at 11kv HV Panel

Partial Discharge Locator Reading: 32dB

Defects: Burn marks on cable insulation

Possible Cause: Air voids within cable sleeves caused by defective termination

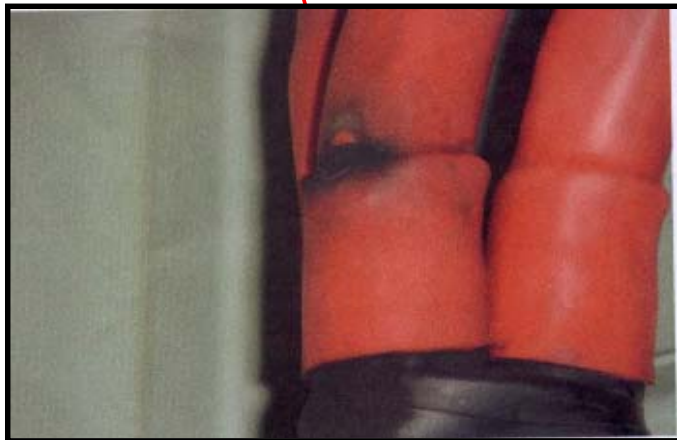
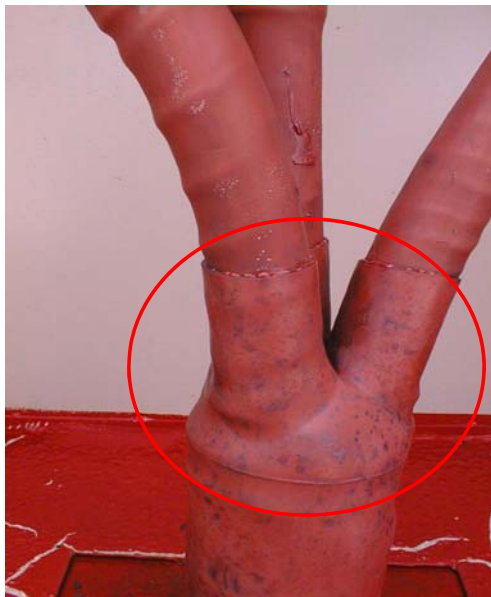
Equipment: Cable Termination at 11kV HV Panel

Partial Discharge Locator Reading: 35dB

Defects: Discolouration on cable insulation

Possible Cause: Ozone from ionization attack on cable surface

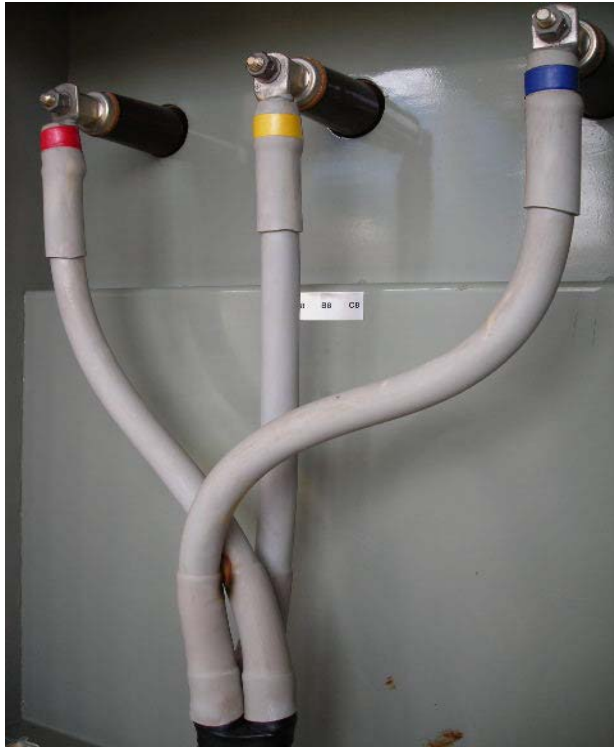
Equipment: Cable Termination at 11kV
Transformer Compartment

**Partial Discharge
Locator Reading:** 35dB

Defects: Burn Marks between the
B & R phase cables

Possible Cause: Arcing between the phases
due to insufficient spacing
between phase cables

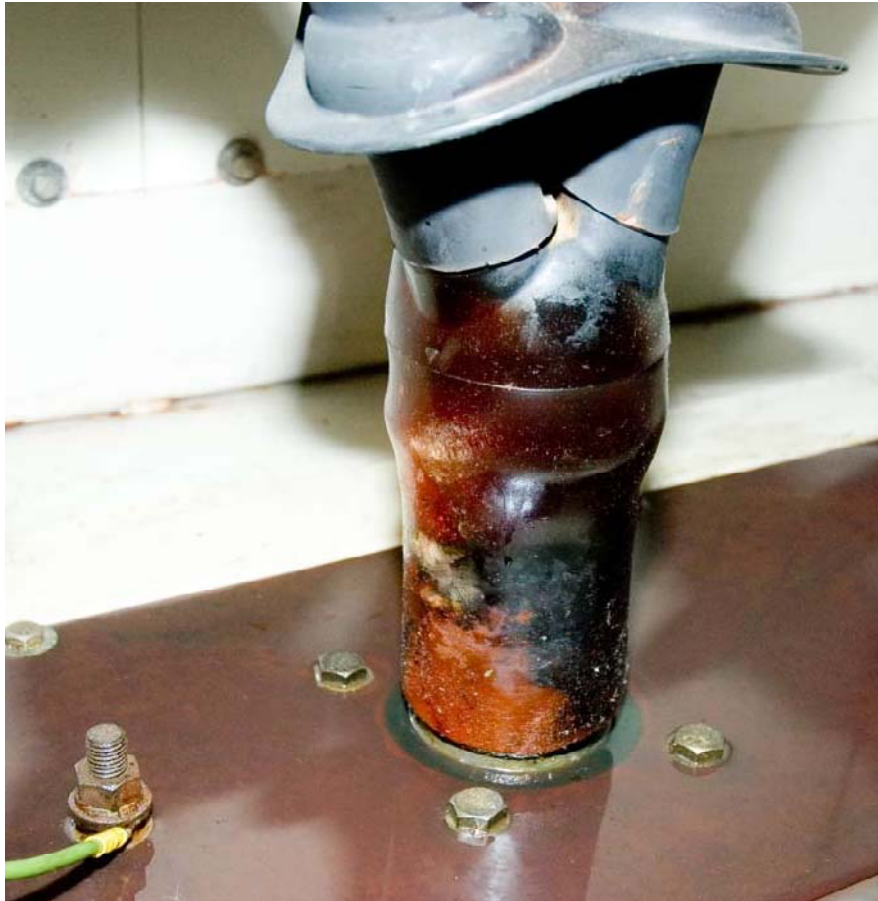
Equipment:	Cable termination at 33kV transformer panel
Partial Discharge Locator Reading:	20dB on outside panel surface but 35-40 DB on surface of internal panel close to fault
Defects:	Heavy discolouration of cable surface, slight burn marks
Possible Cause:	Voids within internal insulation

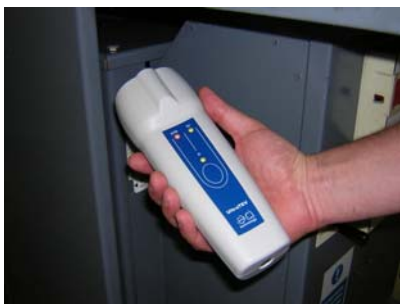
The UltraTEV Instrument

The UltraTEV detects the presence of both surface and TEV discharges and indicates, using different coloured LEDs, if further investigation is required. This instrument is designed for use by staff with minimal training and is used extensively for a first pass indicator for the presence of partial discharge.

This low cost instrument, the first to combine both electromagnetic and ultrasonic testing capabilities, has changed the way in which a number of power utility companies throughout the world approach the condition assessment and management of switchgear assets and at the same time enhances the safety of operators working on the system.

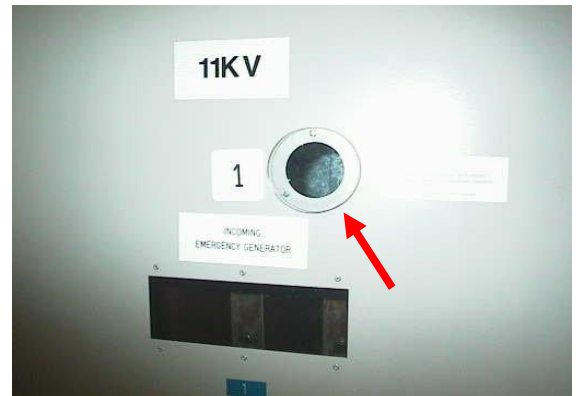
Busbar Terminations of a Switchgear as seen thru the HVIR Window

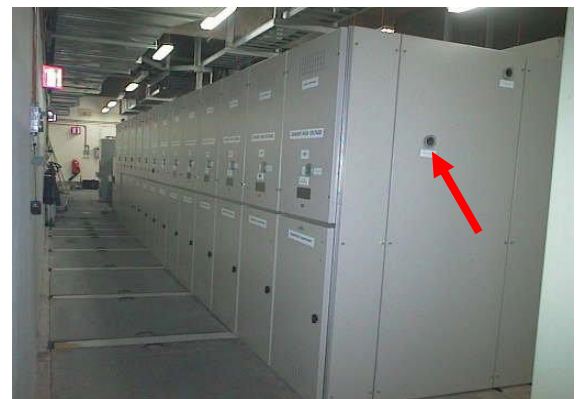
Busbar Chamber of a Switchgear as seen thru HVIR Window installed at Busbar chamber

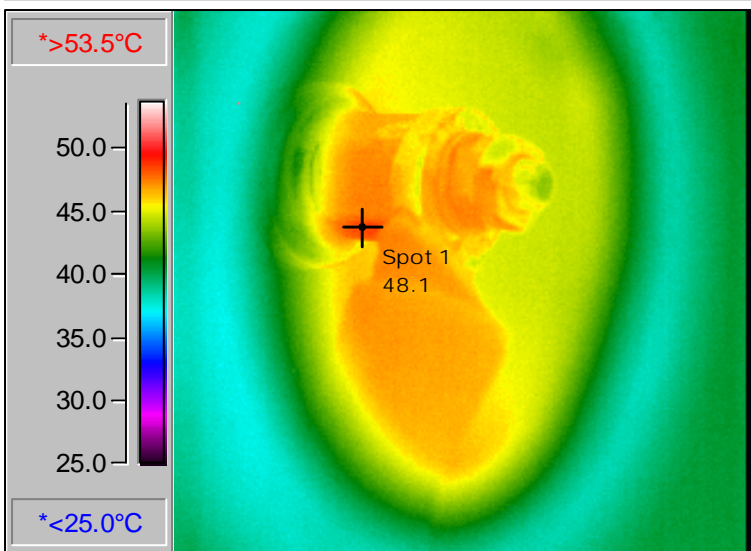
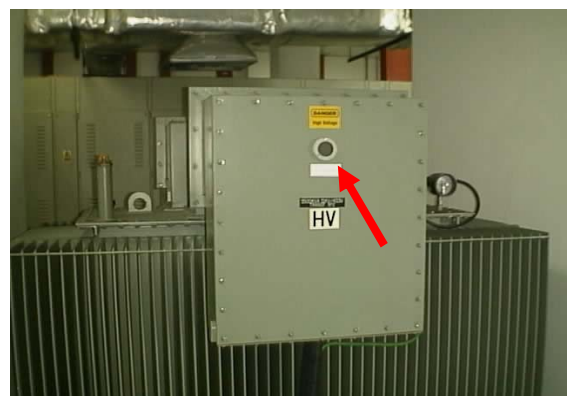
Transformer Terminations as seen thru HVIR Window

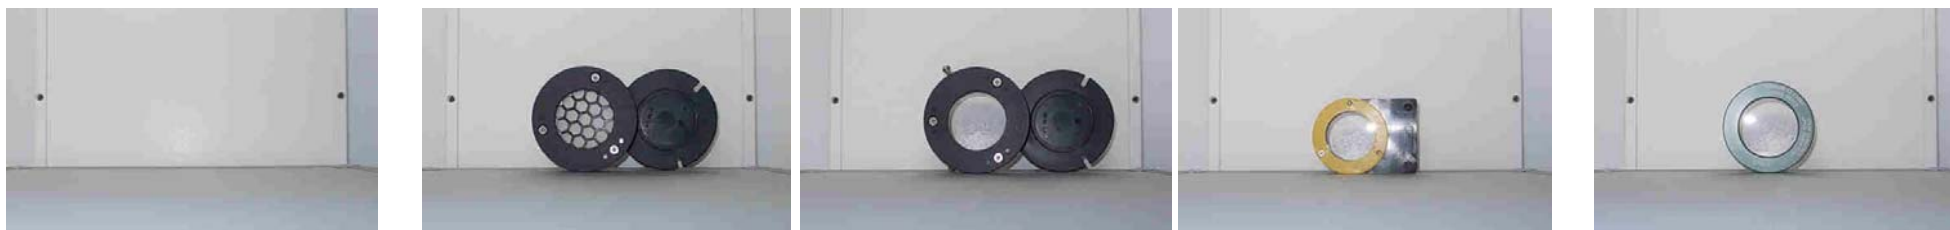
Comparison of Temperatures between various type of Infrared Windows

A Hot Pad is heated up to 65.4°C. Windows or various brands is put in between the hot Pad and the Infrared Thermal Camera. The settings on the Infrared Thermal camera remains constant throughout the test.

IRISS Polymer Window = 40.9°C = 37% error from actual Hot Pad temperature
 IRISS Crystal Window = 42.0°C = 36% error from actual Hot Pad temperature
 Fluke Crystal Window = 46.0°C = 30% error from actual Hot Pad temperature
 SOREM Crystal Window = 58.8°C = 10% error from actual Hot Pad temperature

The errors on other brands range from 30 - 37% of the actual temperatures of objects seen through these Infrared Windows. As such, an electrical components seen through a IRISS Polymer Window could show a temperature of 63°C when the actual temperature is 100°C!!

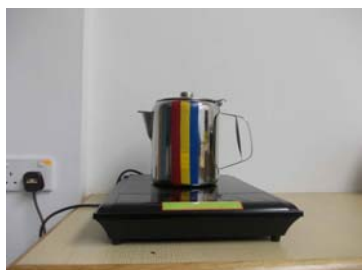
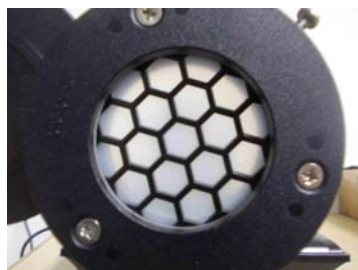
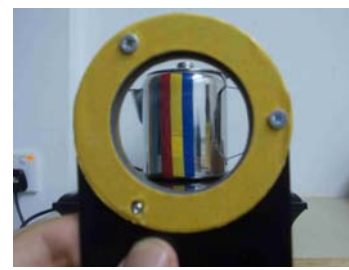
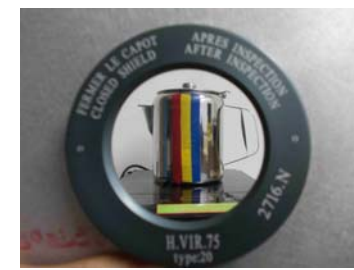
See-ing through the Infrared Windows

As can be seen above, Polymer type windows DO allow Infrared Cameras to 'see-through' with a slight thermal variation, BUT visually, it is opaque. Hence any evidence of Partial Discharge faults on High Voltage Switchgears and Transformers which do not produce any heat, will not be detected as polymer windows does not allow one to see through visually. This is seen as a disadvantage to the electrical engineer and his Condition Monitoring team.

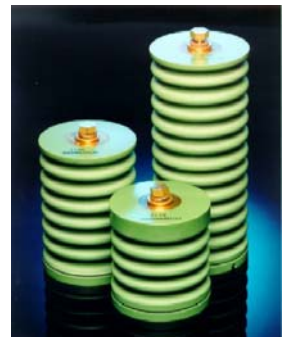
In any of the above cases, permanently installed PD sensors, 80pF capacitive Bus Couplers (shown to the left) specifically designed to work with partial discharge frequencies (50MHz-250MHz typically) need to be installed. These high voltage capacitors create a high pass filter to allow PD signals through for measurement. Iris has sold over 25,000 of these sensors around the world. Worthy of mention is that not one has ever failed. In fact, the IEEE has specified a theoretical operating life of about 60,000 years!!! We'll all be retired by then...
