# *Infrared Thermography (IR)*

## TYPICAL THERMOGRAMS OF HOTSPOTS ON ELECTRICAL EQUIPMENT

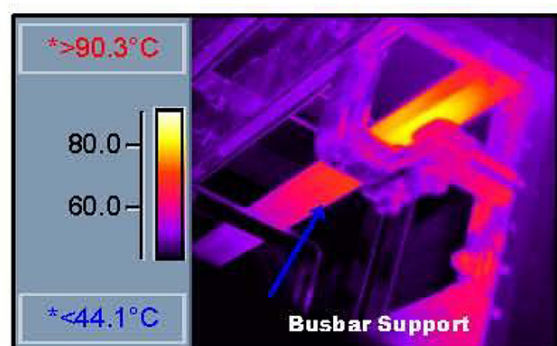
This busbar support in the Main Switchboard is being heated up by the eddy current from the surrounding busbars.

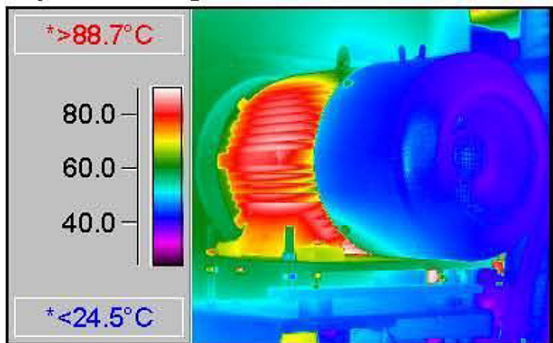
These 2 motors are of the same size and operating under the same load conditions. So why is there a temperature difference? Infrared Thermography can locate initial problems on a motor before the problem deteriorates.

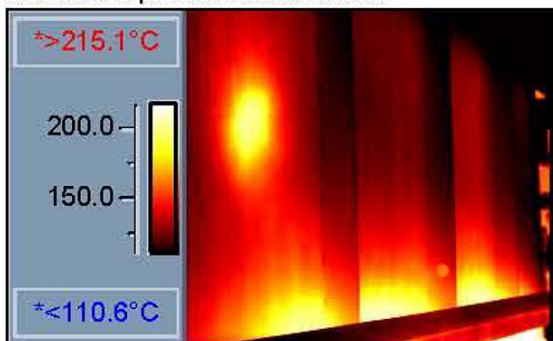
On major Mechanical surfaces, InfraRed Thermography can locate Hotspots indicating refractory failure or deteriorating insulation on the equipment. Why shutdown to locate the problem when you can monitor the situation until the next scheduled shutdown.

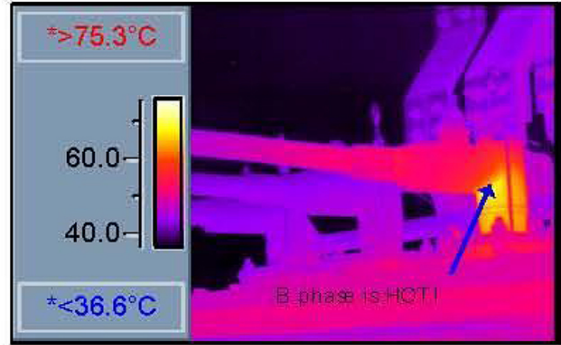
Notice that the B phase of this Transformer is HOT compared to the other 2 phases.

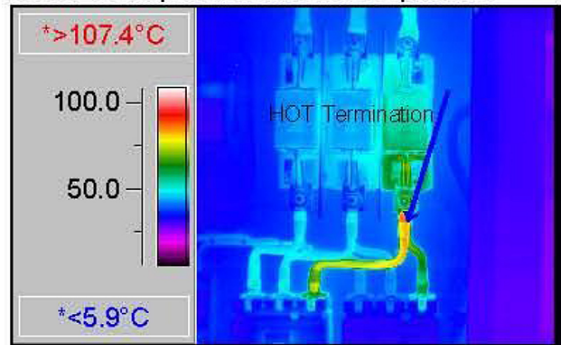
Spot the difference!!! With InfraRed, you can pinpoint a small problem before it becomes a bigger problem.

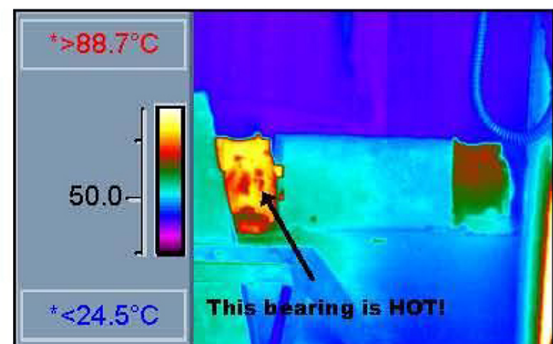
There is a difference in temperature on the bearings, this might indicate a potential. Infrared Thermography finds problems before they become catastrophes.

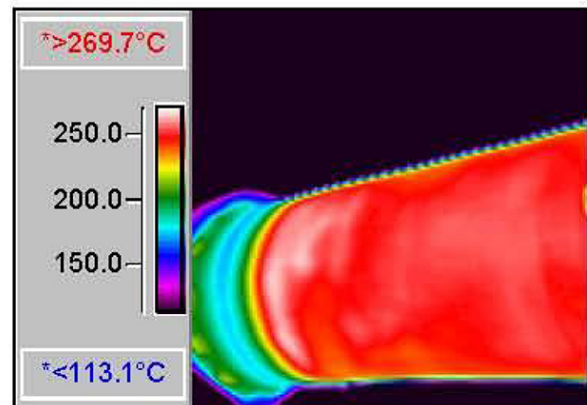
Surface of the Kiln shows uneven temperature distribution.
